CALSPAN REMOTE AIR BAG DEPLOYMENT INVESTIGATION

[REDACTED] CALSPAN CASE NO. 93-7

VEHICLE - 1993 VOLVO 850 GLT

ACCIDENT DATE - [REDACTED], 1993

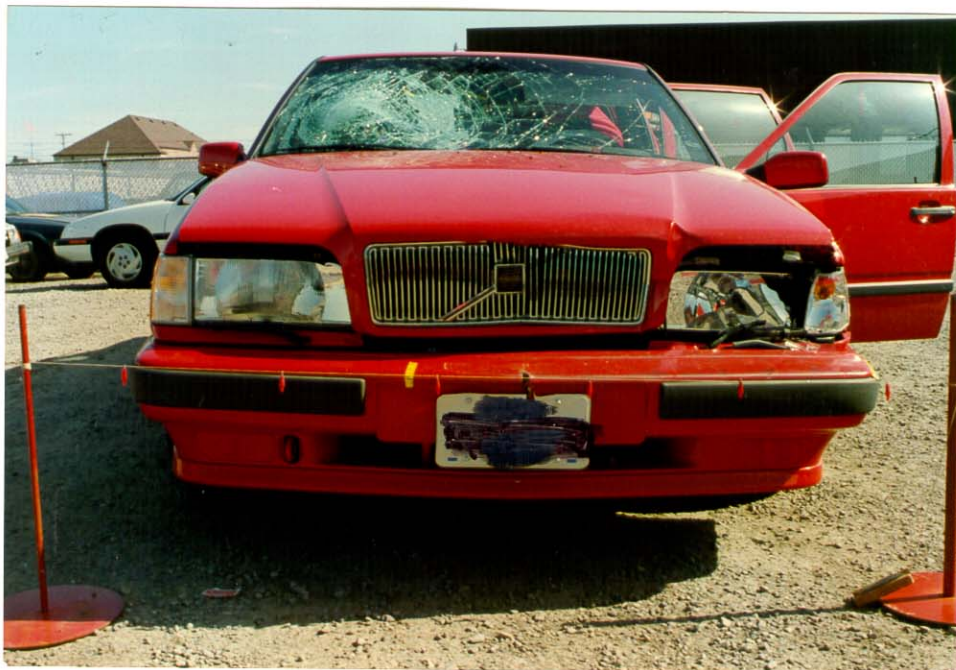
9

Frontal Damage to the Volvo 850 GLT

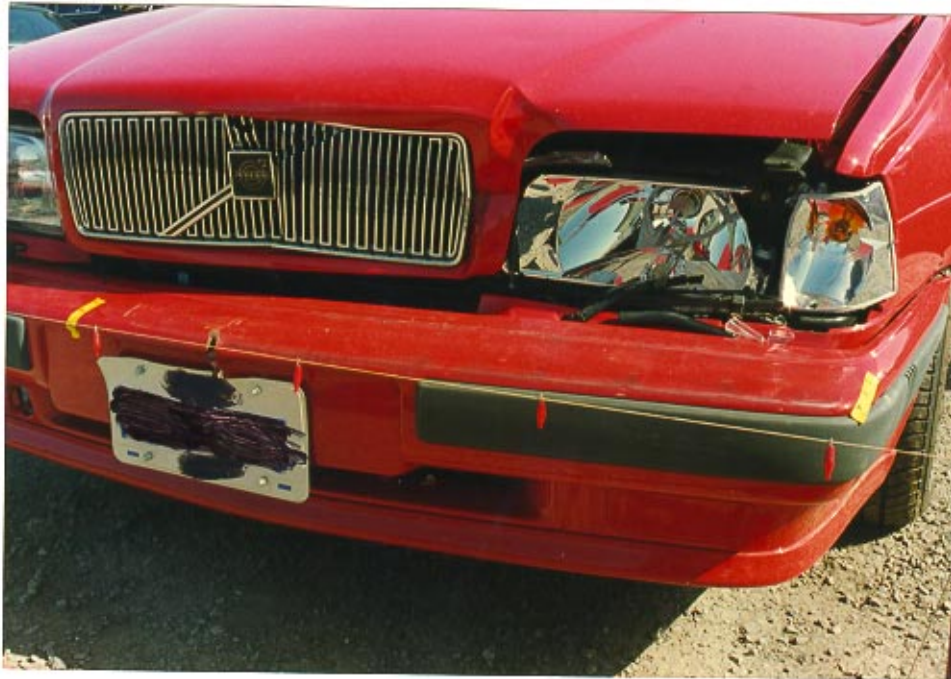
10

Close-up View of the Frontal Damage

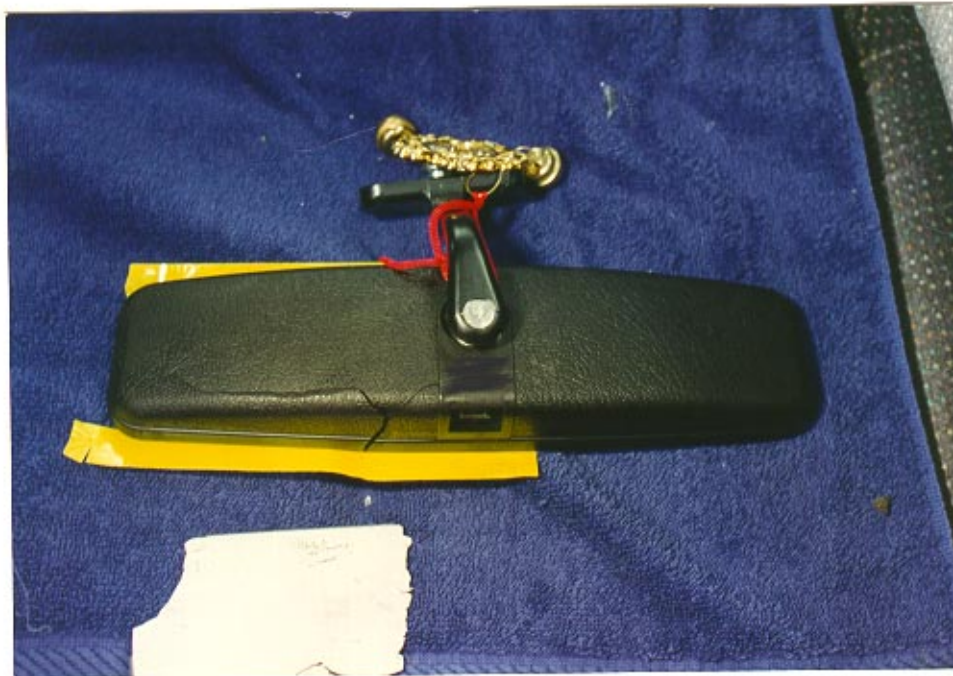
35

Mirror Damage that Resulted from the Child Occupant's Head Impact

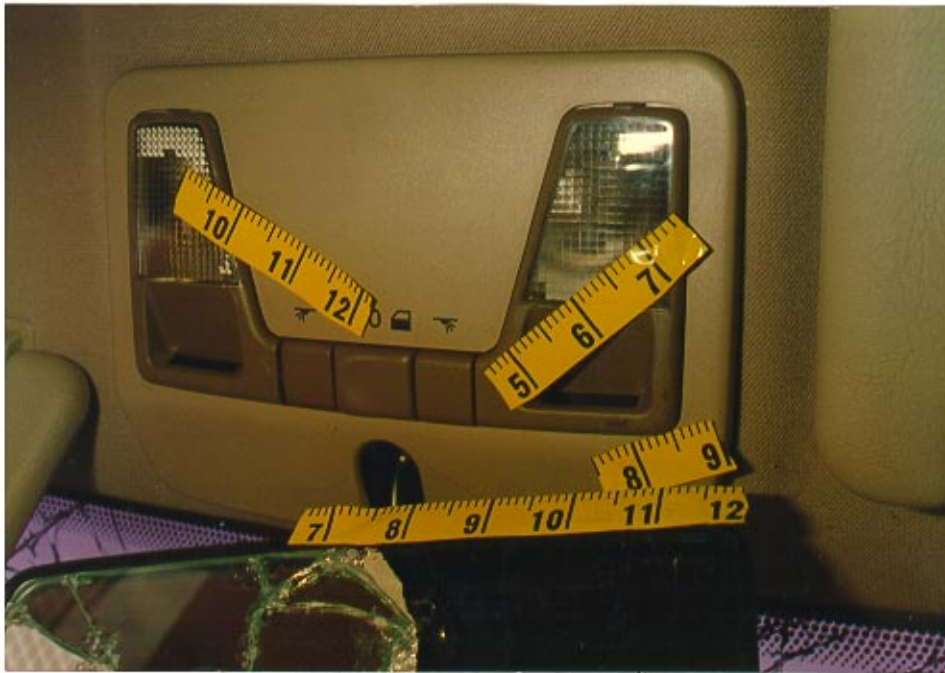
36

Mirror was Displaced into the Map Light Console on the Roof and Disengaged from the Mount

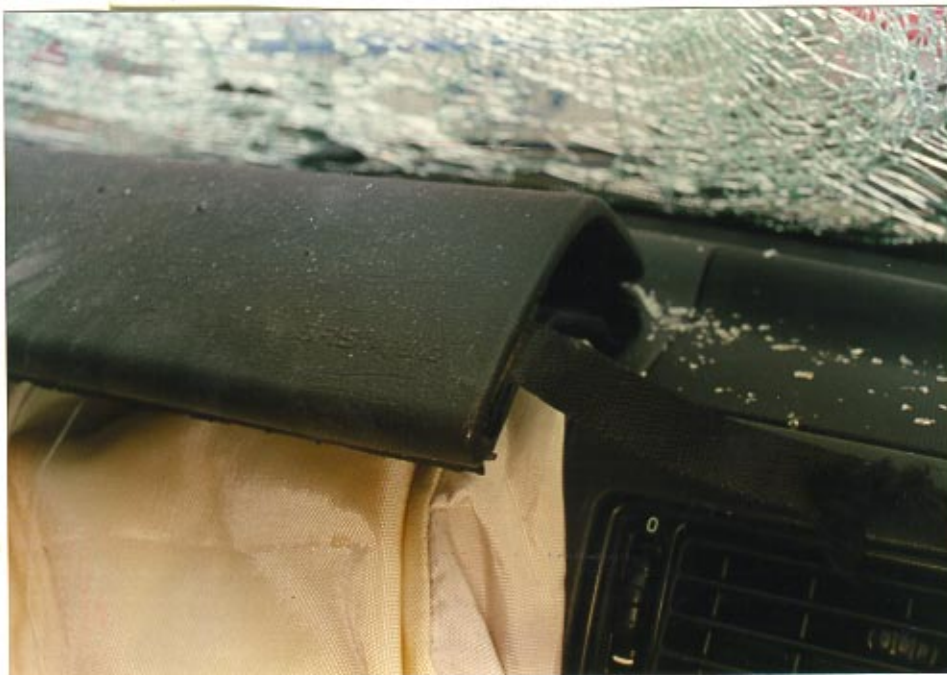
37

Right Corner of the Passenger Air Bag Module Cover Flap Impacted and Cracked the Windshield; Right Tether (Limiter) Strap for the Module Cover Flap Separated

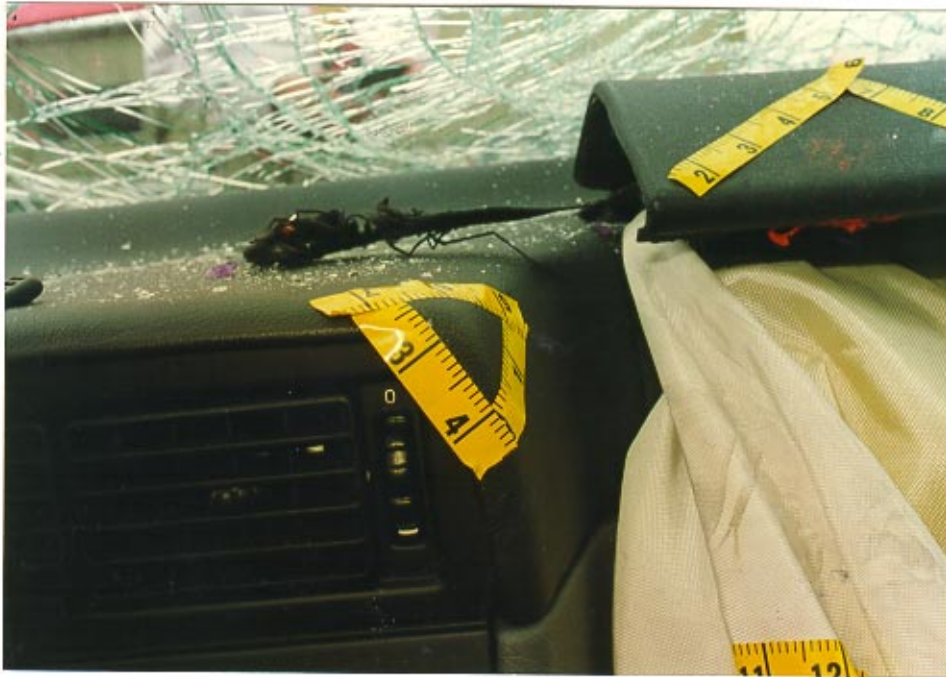
38

Left Module Cover Tether Strap Separated

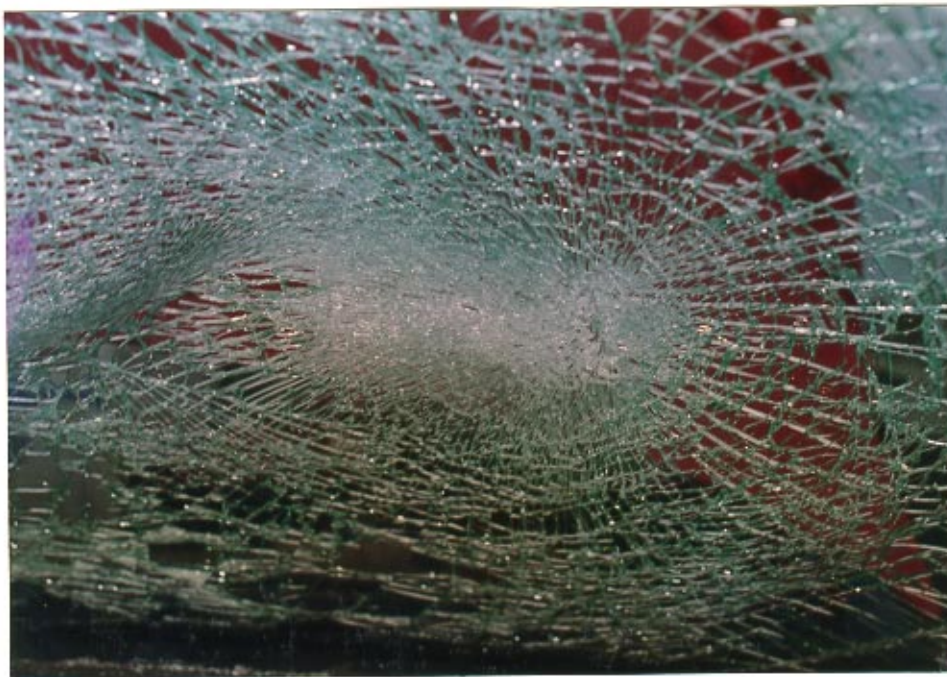
39

Windshield Impact Area from Passenger Air Bag Module Cover Flap,
Vinyl Transfers Embedded into Broken Glass

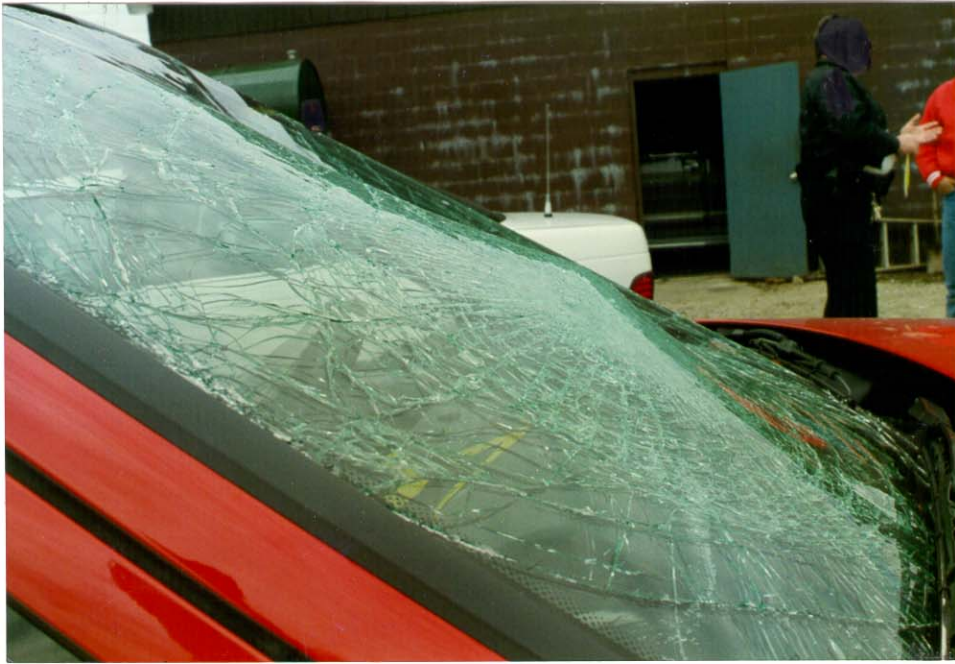
40

6.4 cm (2.5") of Outward Bowing to Windshield from Module Cover Flap Contact

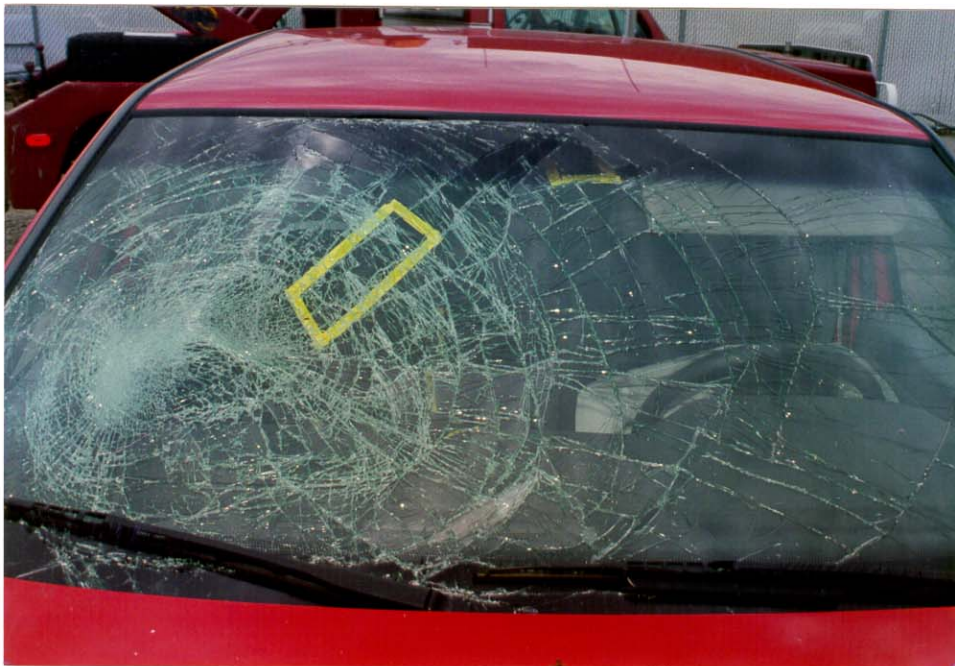
41

Damage to Windshield that Resulted from Module Cover Flap Contact

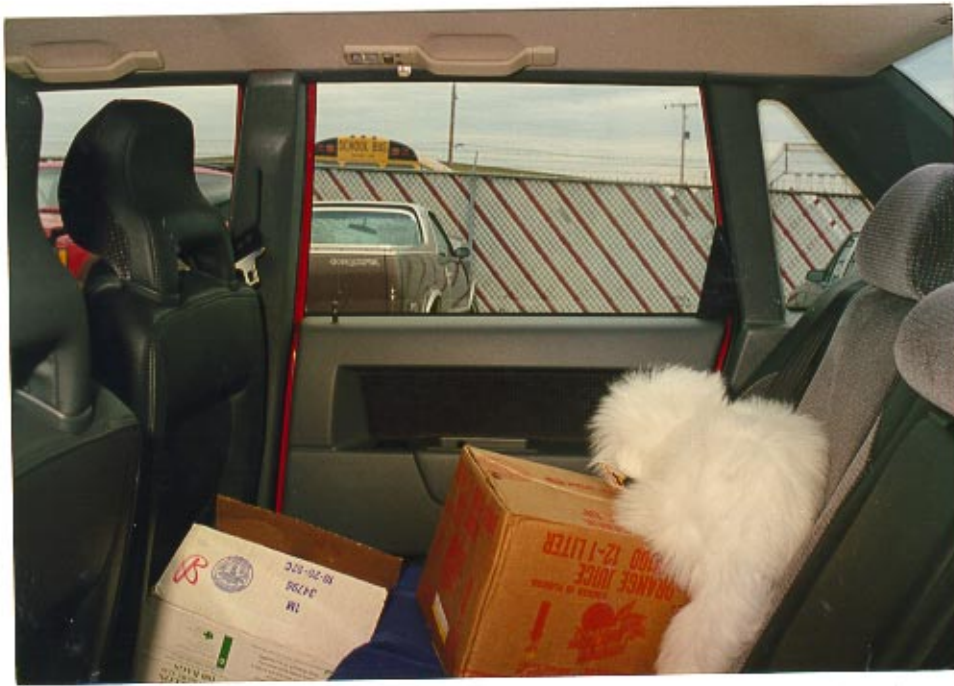
42

Right Front Passenger's Manual Belt Locked Against the B-pillar

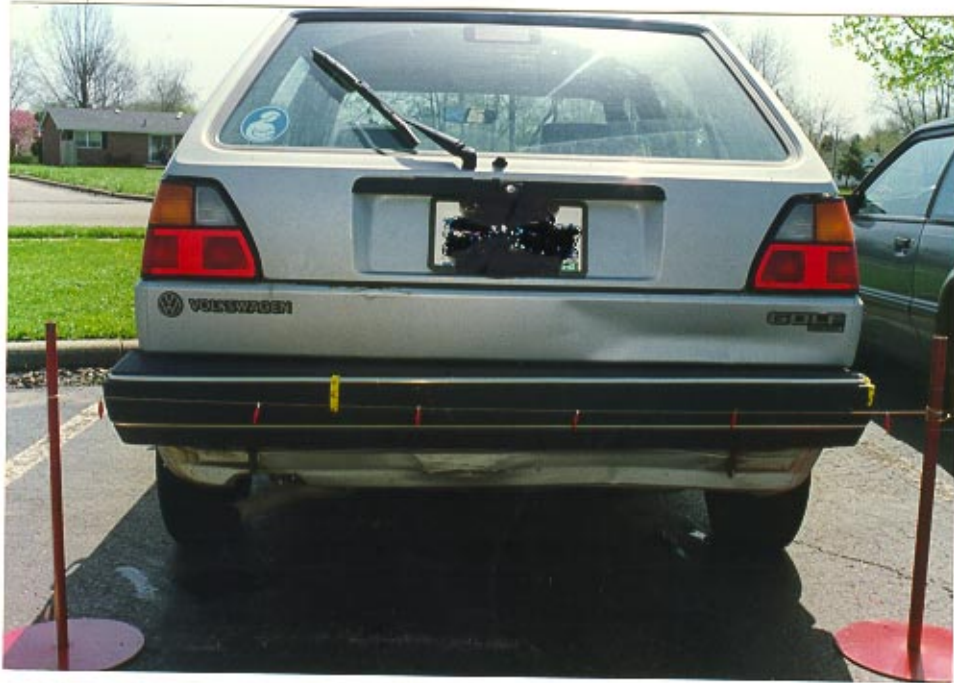
49

The Volvo impacted the right two-thirds of the rear area of vehicle #2. Direct contact damage began 31.1 cm (12.3") left of center and extended 105.2 cm 41.4" to the right corner. The contact damage consisted of abrasions to the bumper face and deformation to the sheetmetal panels above and below bumper level. The impact displaced the bumper forward which resulted in a full width induced and direct contact damage length of 150.6 cm (59.3"). Crush values at bumper level were as follows:

Rear Damage to Vehicle #2

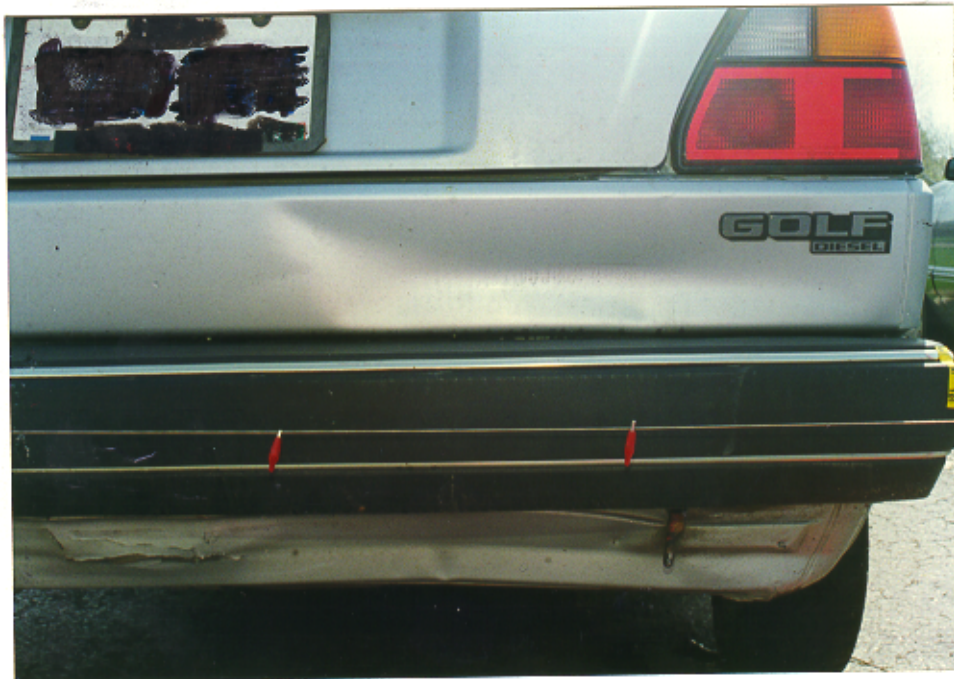
52

Direct Contact Damage Begins 12.25" Left of Center
and Extends 41.4" to the Right Rear Bumper Corner

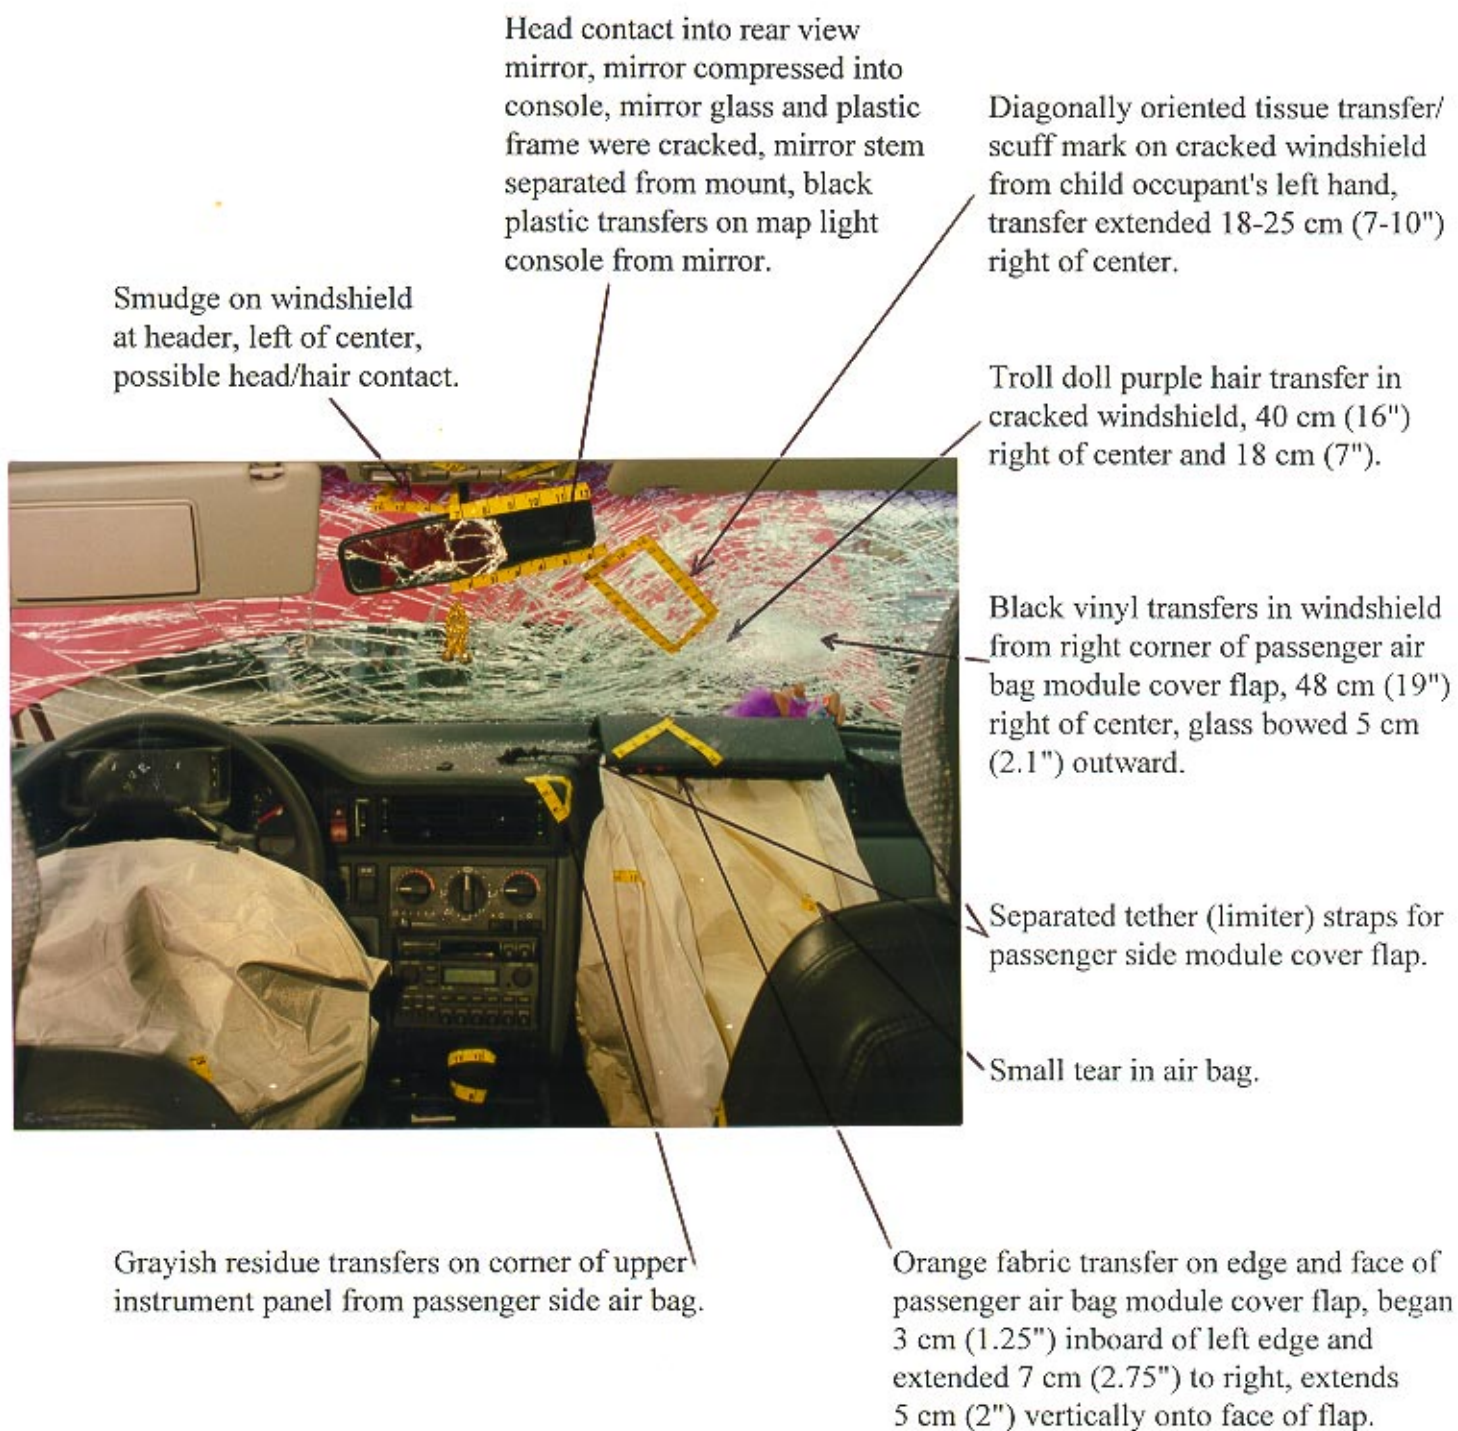
Child Occupant Contact Points

Contact	Interior Component Contacted	Occupant No. If Known	Body Region If Known	Supporting Physical Evidence	Confidence Level of Contact Point
A	45	1	FACE	LIPSTICK TRANSFER	1
B	45	1	FACE	MAKEUP TRANSFER	1
C	17	2	① ARM/TORSO	ORANGE FABRIC TRANSFER	1
D	01	2	② HAND	TISSUE / SCUFF	1
E	01	2	HEAD	SMUDGE	2
F	02/50	2	HEAD	CRACKED / DISPLACED MIRROR	1
G	01	2	—	CRACKED, MODULE COVER FLAP	1
H					
I					
J					
K					
L					
M					
N
